**CWA RECONNAISSANCE INSPECTION REPORT
U.S. ENVIRONMENTAL PROTECTION AGENCY, REGION 5**

Purpose: Compliance Evaluation Reconnaissance Inspection

Facility: Breese Site Hog Farm
19722 Low Bridge Road
Breese, Illinois 62230

Date of Inspection: May 20, 2011

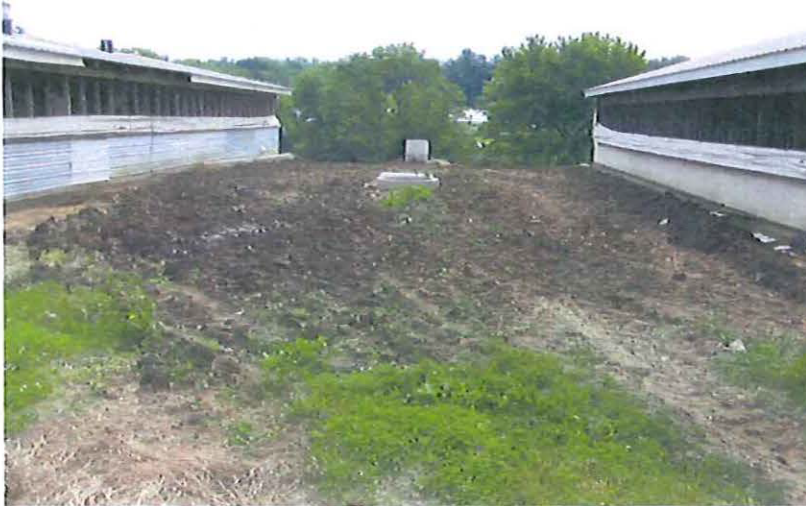
IMG_0282: Ground between barns has been graded and seeded.
Location: Between Barn #3 and Barn #4.
Facing: East
Date/Time: 05/20/11 9:30 A.M.

On the date of this inspection, [FOIA Exemption (b) (6)] showed EPA the improvements that had been made to the area between the barns. [FOIA Exemption (b) (6)] had added rock and stone to the base of the barn walls to facilitate the draining of storm water. The ground between the barns had been graded and re-seeded. While doing this grading, [FOIA Exemption (b) (6)] discovered the terminus of a suspected storm water pipe and the ground around it was graded to allow the storm water to flow to the storm water pond. [FOIA Exemption (b) (6)] added extensions to the cleanouts alongside the building and capped the cleanout pipes to prevent the addition of clean water into the pits below the buildings. [FOIA Exemption (b) (6)] stated that he had identified that the reason that the furthest east cleanout had previously discharged was because it was lower in elevation than the pit below the barn. He has since added an

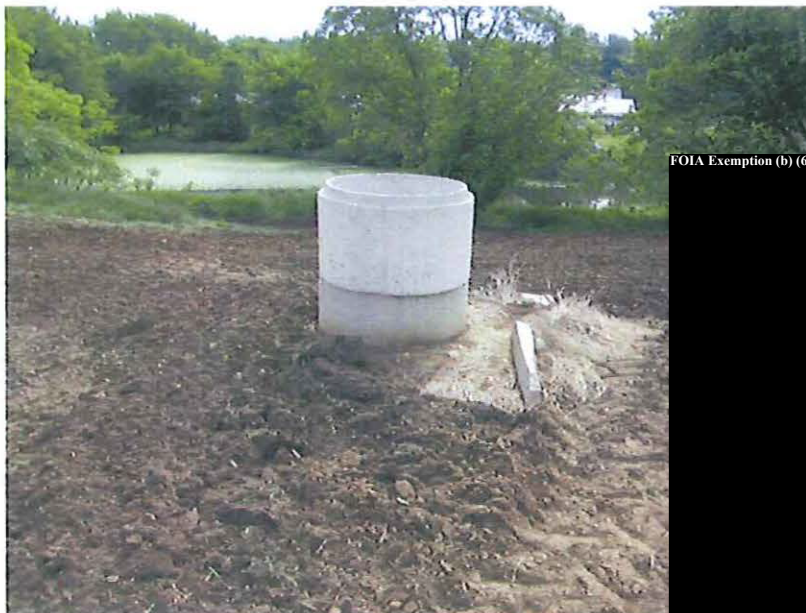
IMG_0284: Cleanout furthest east has had additional concrete pipe installed to prevent discharges. Previously, the cleanout was at a lower elevation than the barn pits. Now it is higher.
Location: Between Barn #3 and Barn #4.
Facing: East
Date/Time: 05/20/11 9:31 A.M.

additional ring of concrete to raise the height of the furthest east manhole cleanout to prevent any overflows.

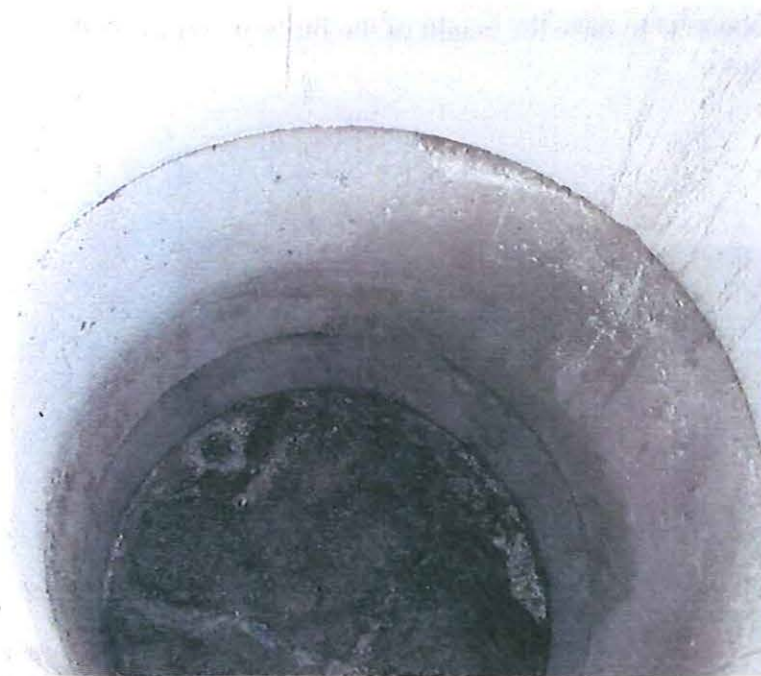
IMG_0285: Level of manure in furthest east cleanout is low.
Location: Between Barn #3 and Barn #4.
Facing: Down
Date/Time: 05/20/11 931 A.M.

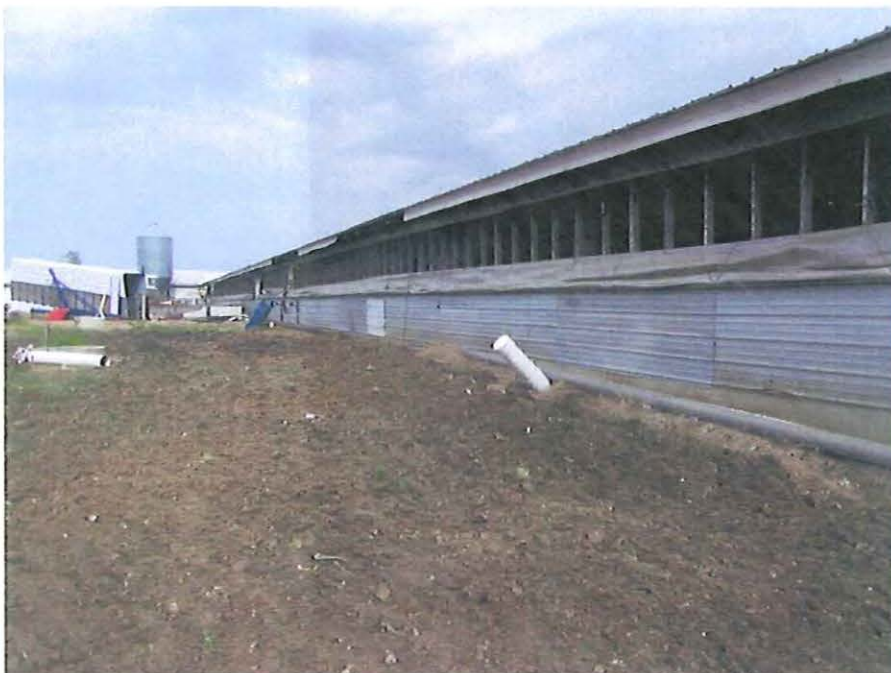
IMG_0286: Cleanout pipe along Barn #3 has been extended and capped to prevent the additon of storm water into the pit below barn.
Location: South of Barn #3.
Facing: Northwest
Date/Time: 05/20/11 9:33 A.M.

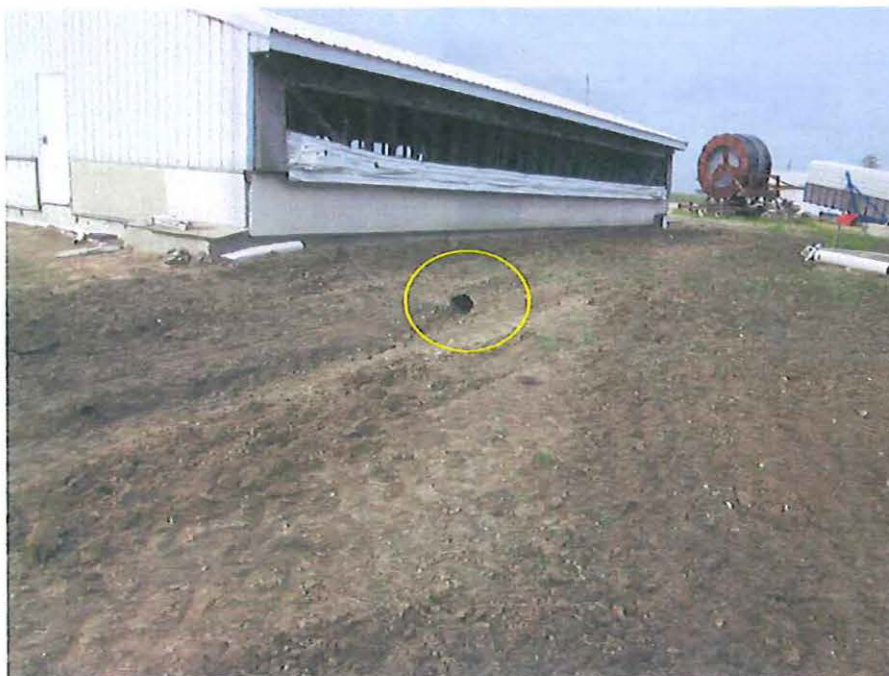
IMG_0287: Storm water pipe was found during regrading. Storm water pipe is identified by yellow circle.

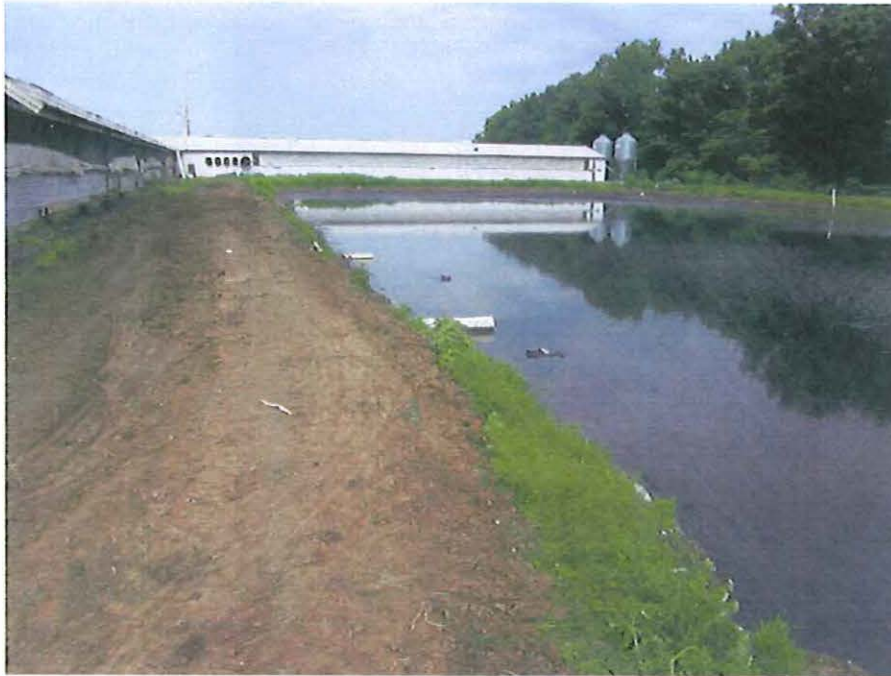
EPA walked around the east side of Barn #3 and observed the Complex Lagoon. The Complex Lagoon receives manure from Barns #1-4. There was more than two feet of freeboard in the Complex Lagoon at the time of the inspection. [FOIA Exemption (b) (6)] stated that there were 1600 weaner pigs in Barn #1 and Barn #2, and there were 400 finisher hogs in Barn #3, for a total of 2000 animals. There were no hogs in Barn #4.

IMG_0288: Complex Lagoon has approximately two feet of freeboard.
 Location: Between Barn #3 and Complex Lagoon.
 Facing: West
 Date/Time: 05/20/11 9:34 A.M.

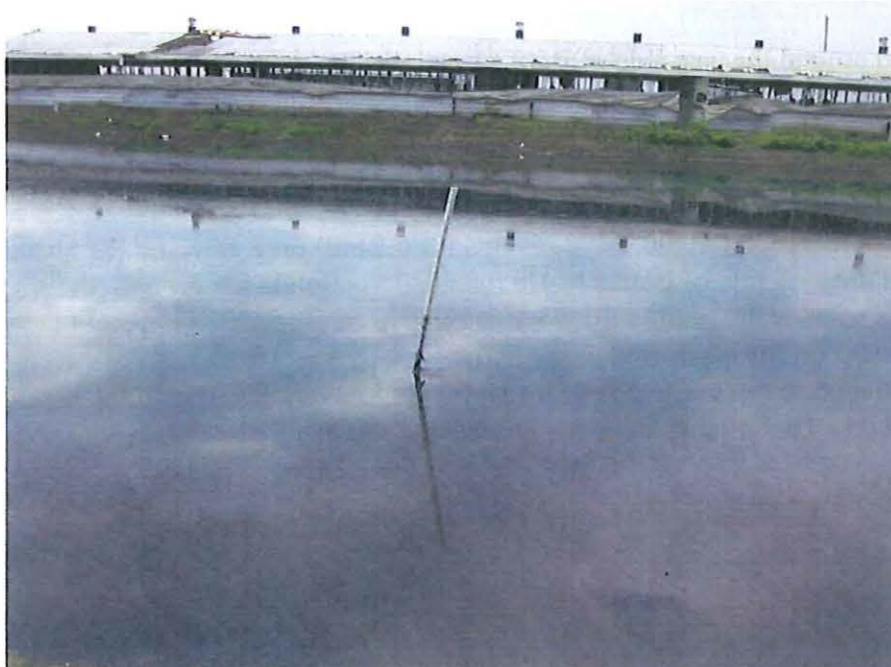
IMG_0293: Staff guage in Complex Lagoon shows two feet of freeboard.
 Location: Northwest corner of Complex Lagoon.
 Facing: South
 Date/Time: 05/20/11 9:40 A.M.

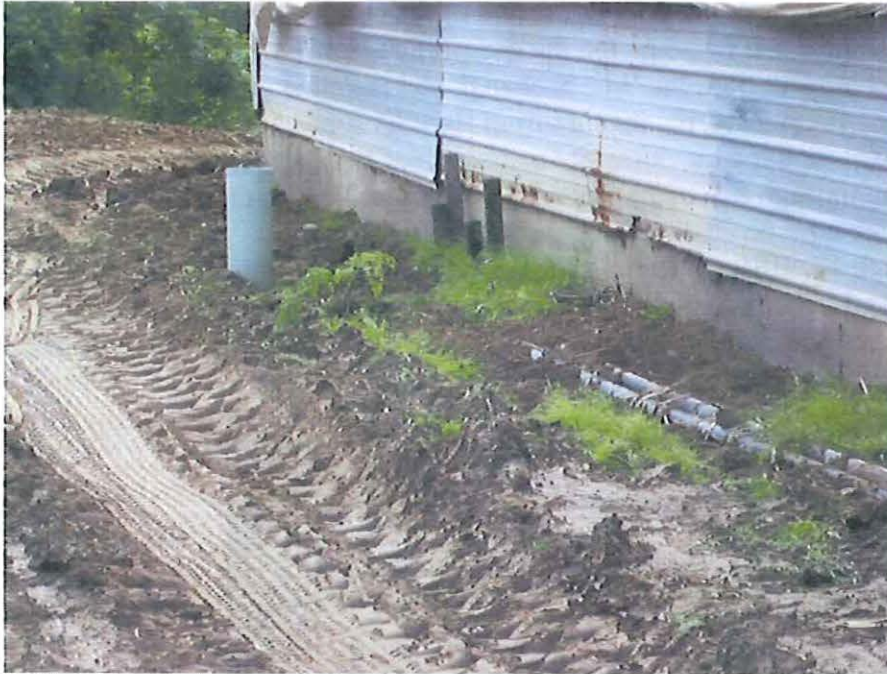
IMG_0290: Valve casing has been repaired.

[FOIA Exemption (b) (6)] had repaired the valve casings for the pull plug valve on the north side of Barn #3 and the east side of Barn #1. He intended to regrade the ground on these sides of the barns as soon as the ground dried out enough to be workable to prevent the ponding of storm water on the north side of the barns.

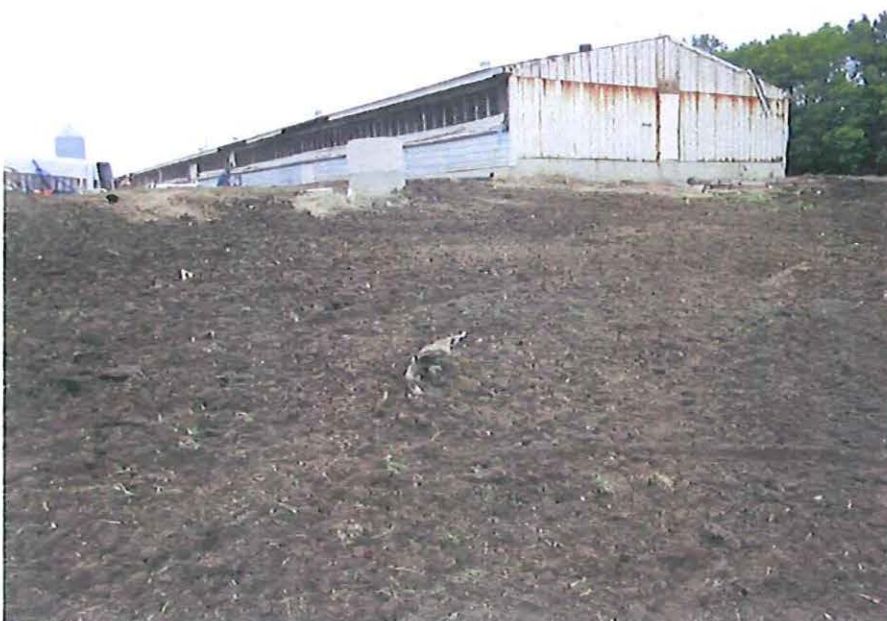
EPA walked around the north side of the Complex Lagoon and then to the hillside east of Barn #3 and #4. The hillside had been graded and reseeded.

IMG_0294: Hillside east of Barn #3 and Barn #4 has been regraded and reseeded.

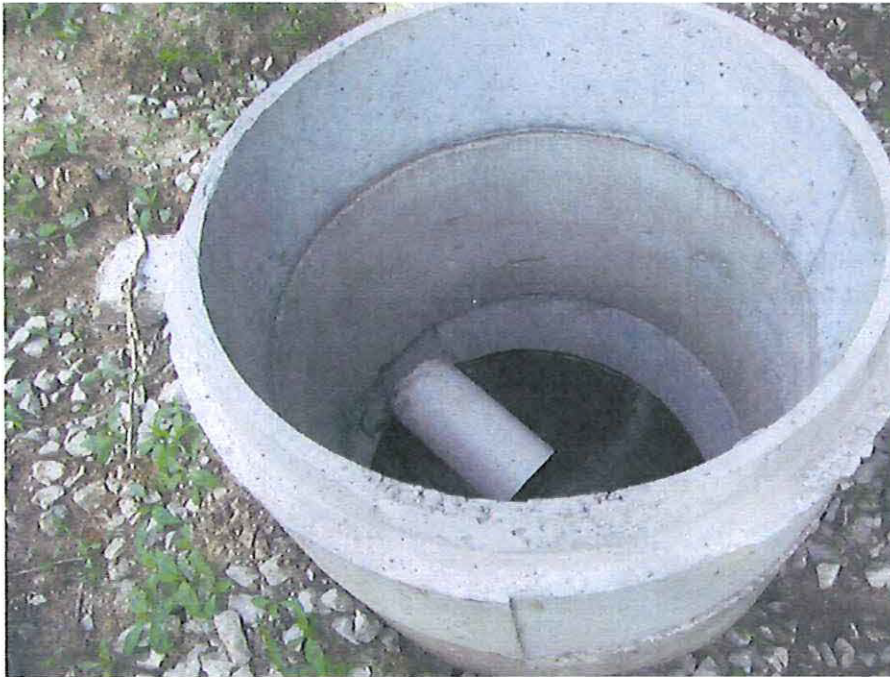
EPA then walked down the driveway south of the storm water pond to observe Barn #5, Barn #6, and the 5-6 Lagoon. On the day of the inspection, there were only 100 hogs in Barn #5 and none in Barn #6. [FOIA Exemption (b) (6)] had installed a new piping system for Barns #5 and #6. Previously, the manure from Barn #5 flowed to a manhole where the manure from Barn #6 joined it. Now the manure from Barn #5 flows separately to the 5-6 Lagoon, passing through two manholes where the flow changes direction. The manure from Barn #6 now flows directly to the 5-6 Lagoon.

IMG_0299: Looking down into cleanout for reworked piping from Barn #5. [FOIA Exemption (b) (6)] dug up and replaced the piping for Barns #5 and #6. Barn #5 manure flows through pipe to first cleanout.

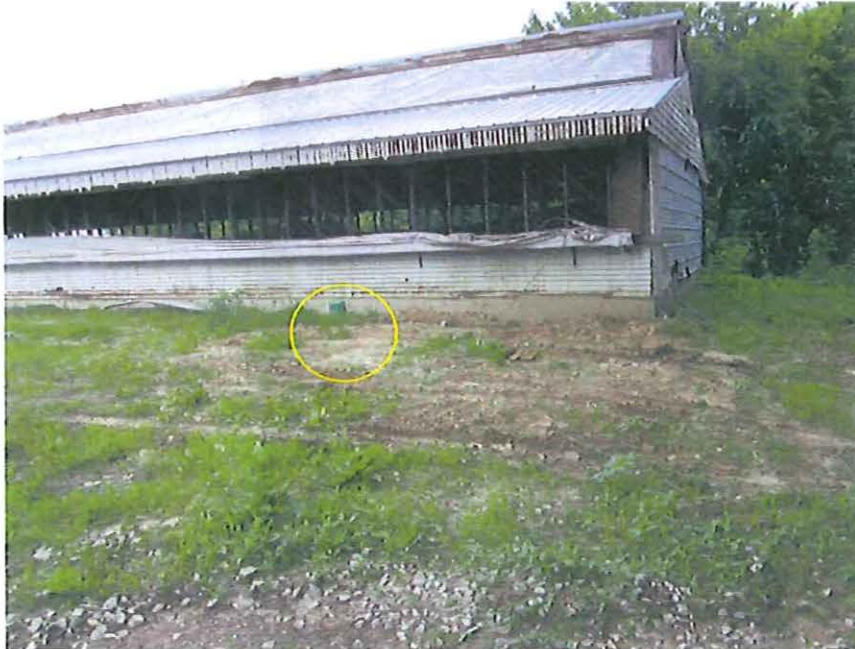
IMG_0300: Valve casing, denoted by yellow circle, for pull plug for Barn #5 by barn wall.

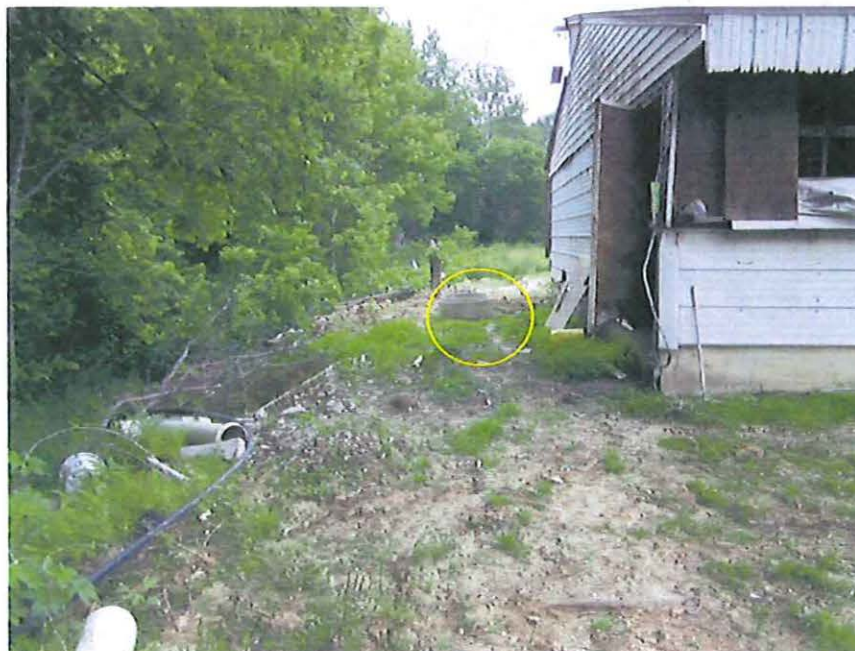
IMG_0301: After exiting first cleanout, manure from Barn #5 flows to second cleanout north of Barn #6. Cleanout is denoted by yellow circle.

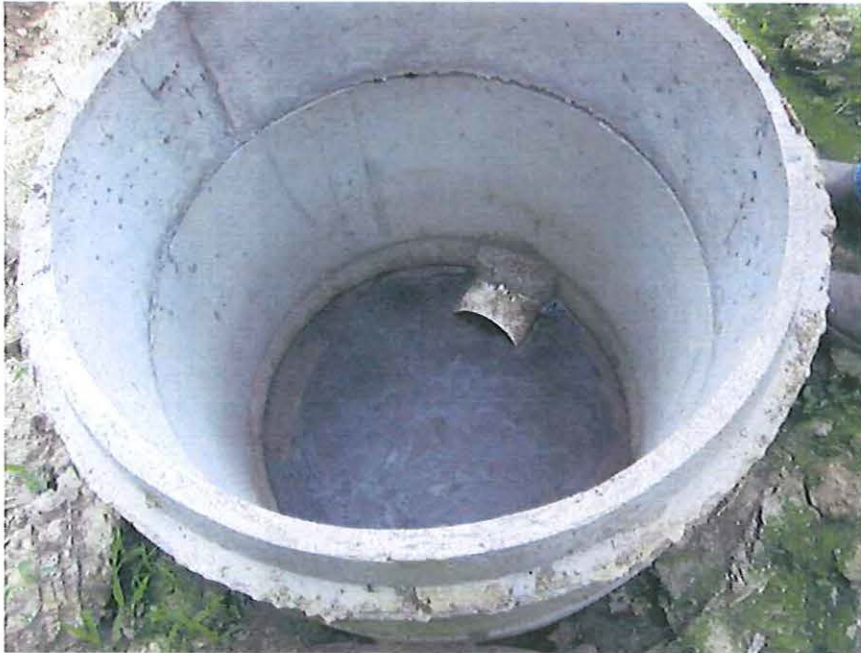
IMG_0302: Second cleanout for manure from Barn #5. Manure level is low.
 Location: North of Barn #6.
 Facing: Down
 Date/Time: 05/20/11 9:47 A.M.

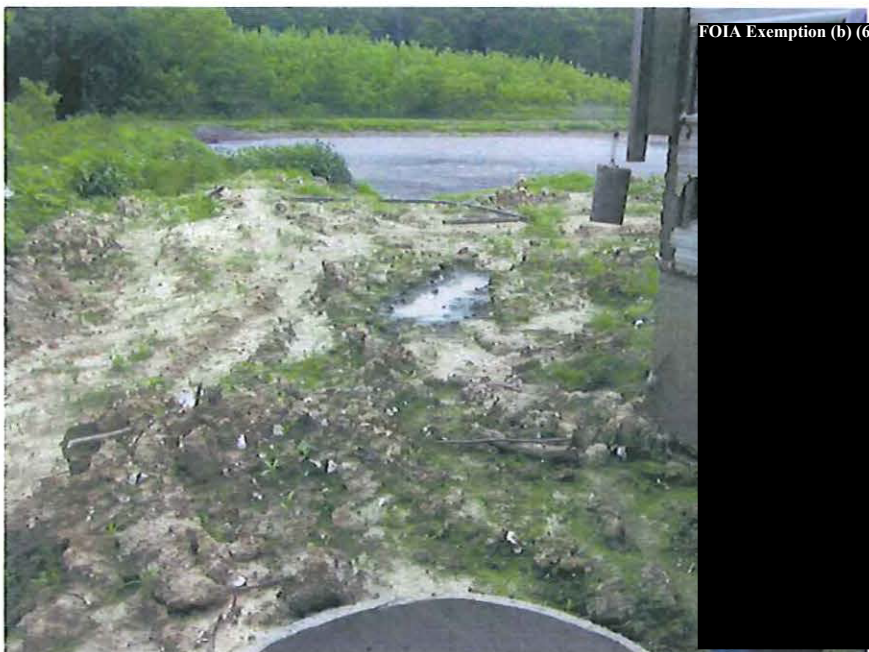
On the March 18, 2010 inspection, EPA documented that a break in the old pipe from Barn #6 allowed manure to discharge down the hillside to the north and to the wetland and Unnamed Tributary of Shoal Creek. This old pipe has been removed and the discharge to the north has been eliminated.

IMG_0303: Manure from Barn #5 then flows directly to 5-6 Lagoon. Manure from Barn #6 flows directly to 5-6 Lagoon now. This location previously had a discharge from broken manure line.
 Location: North of Barn #6.
 Facing: East
 Date/Time: 05/20/11 9:47 A.M.

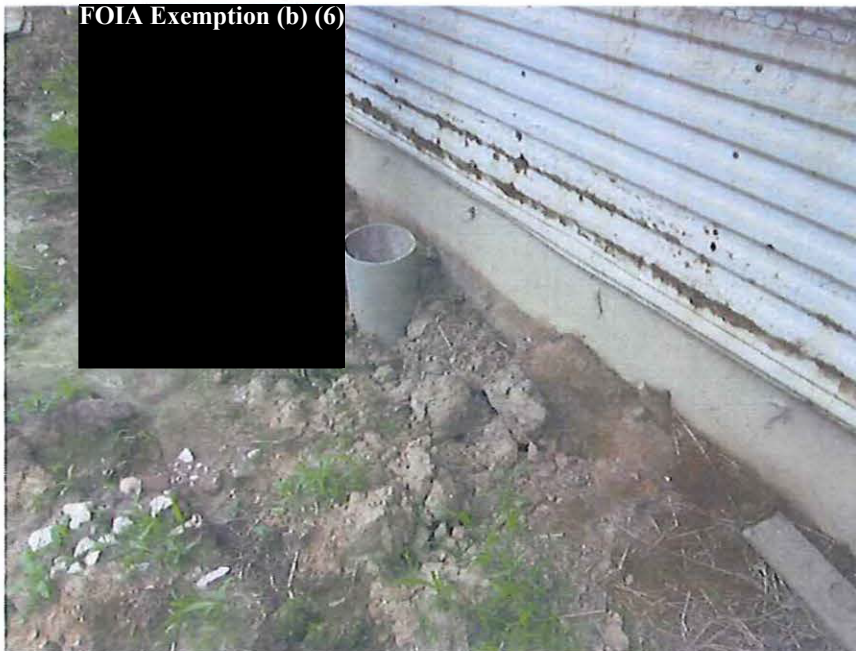
IMG_0304: Valve casing for pull plug for Barn #6.

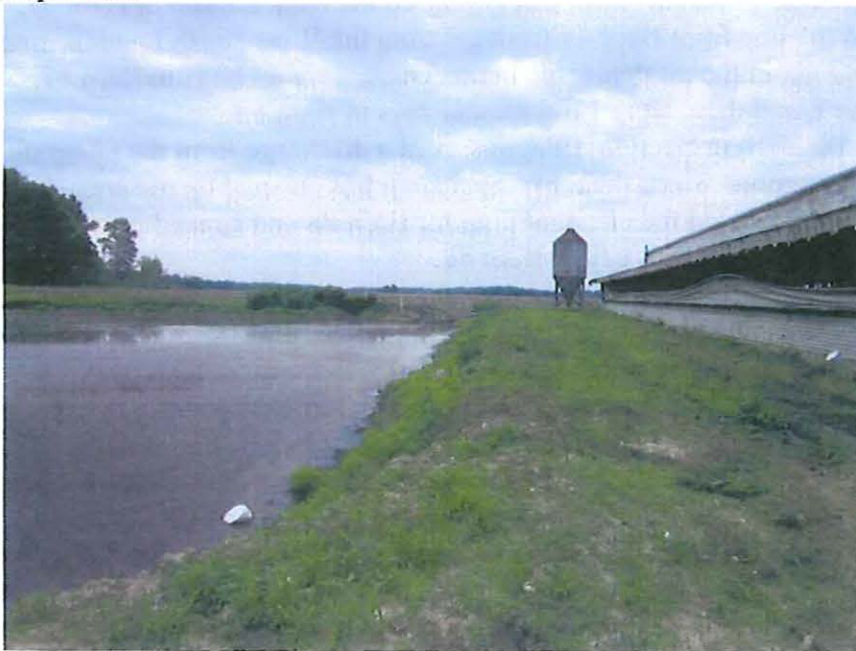
IMG_0308: West berm of 5-6 Lagoon.

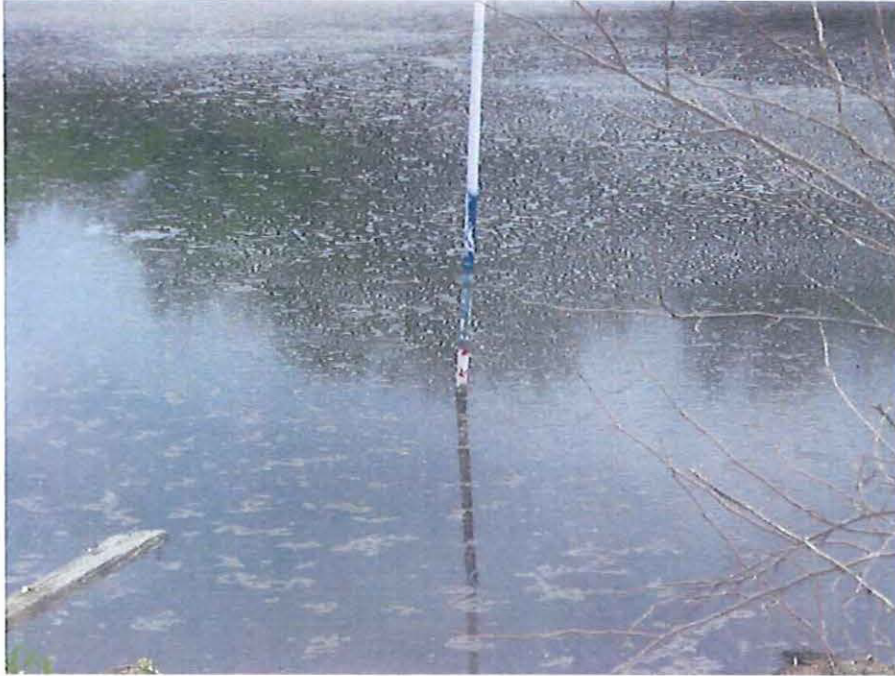
The 5-6 Lagoon had approximately five feet of freeboard on the date of this inspection.

IMG_0316: Staff guage in 5-6 Lagoon shows approximately five feet of freeboard.
Location: South side of 5-6 Lagoon.
Facing: North
Date/Time: 05/20/11 9:53 A.M.

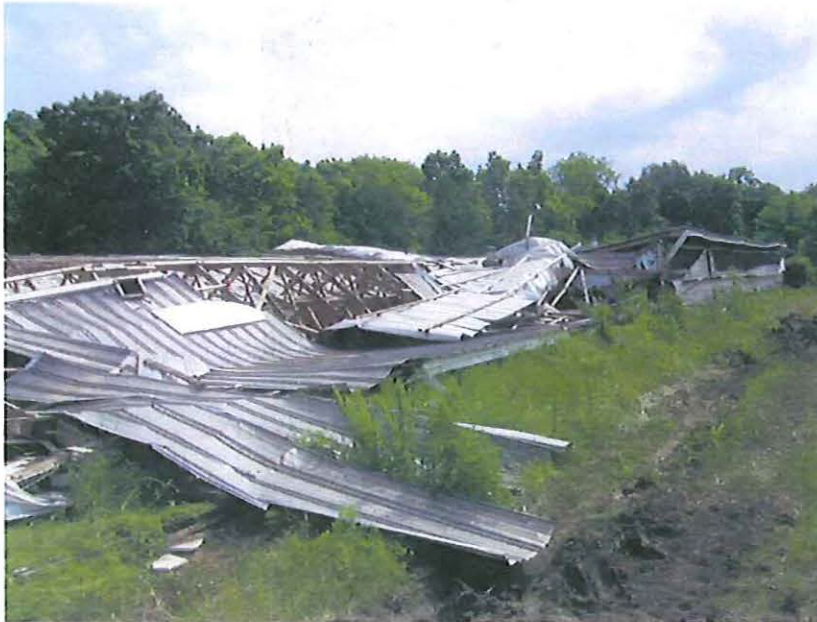
EPA then drove to the north along Low Bridge Road to observe Barn #7, Barn #8 and the two North Lagoons. A recent storm had collapsed the back section of Barn #7. FOIA Exemption (b) (6) blocked the line from Barn #7 from entering the West North Lagoon, since storm water was able to get in the pit below the barn. There were no hogs in Barn #7, due to the collapsed roof, and there were 1400 weaner pigs in Barn #8.

IMG_0326: Severe weather cause the collapse of part of Barn #7.
Location: South of Barn #7,
Facing: Northeast
Date/Time: 05/20/11 10:15 A.M.

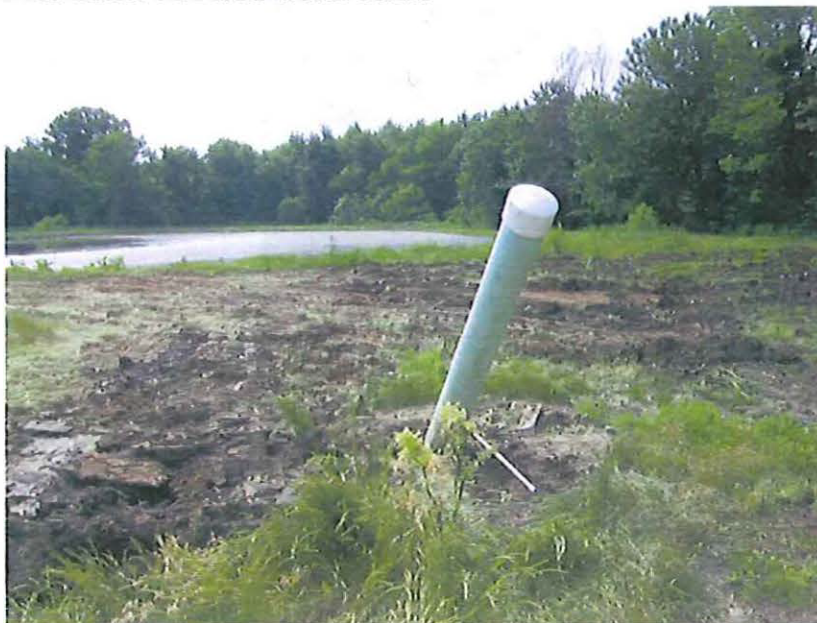
On the March 18, 2010 inspection, EPA observed a discharge from the pump out area of the West North Lagoon. Since then, FOIA Exemption (b) (6) has cleaned up the area around the pump out and extended the cleanout pipe for Barn #8 and capped it to prevent the addition of storm water into the pit below Barn #8.

IMG_0322: Cleanout for pipe from Barn #8 has been extended and capped. Land around the lagoon has been regraded.
Location: West of West North Lagoon.
Facing: Southeast
Date/Time: 05/20/11 10:12 A.M.

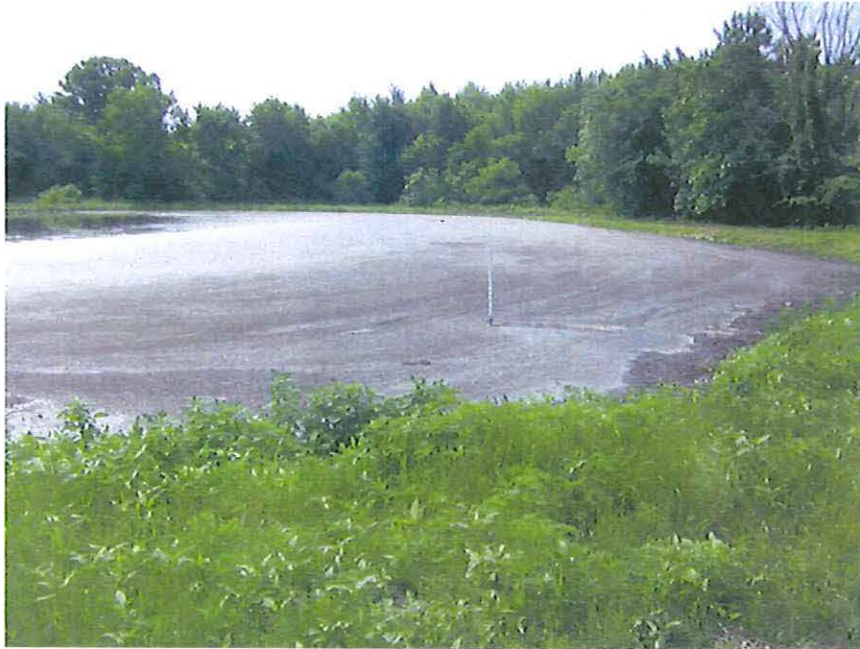
Additionally, during the previous insepction, there was a discharge from the southwest corner of the West North Lagoon down the hillside to the Unnamed Tributary of Shoal Creek, due to the overfilling of the lagoon. On this inspection, there was approximately six inches of freeboard in the West North Lagoon. FOIA Exemption (b) (6) said that he intended to pump from this lagoon soon. Since there wasn't much storage capacity left in the West North Lagoon, EPA questioned FOIA Exemption (b) (6) about the level of manure in the pit below Barn #8. FOIA Exemption (b) (6) opened the door to Barn #8 and EPA observed that the level of manure was not at the top of the pit. FOIA Exemption (b) (6) stated that the pit was only three inches full.

IMG_0324: West North Lagoon and staff guage.

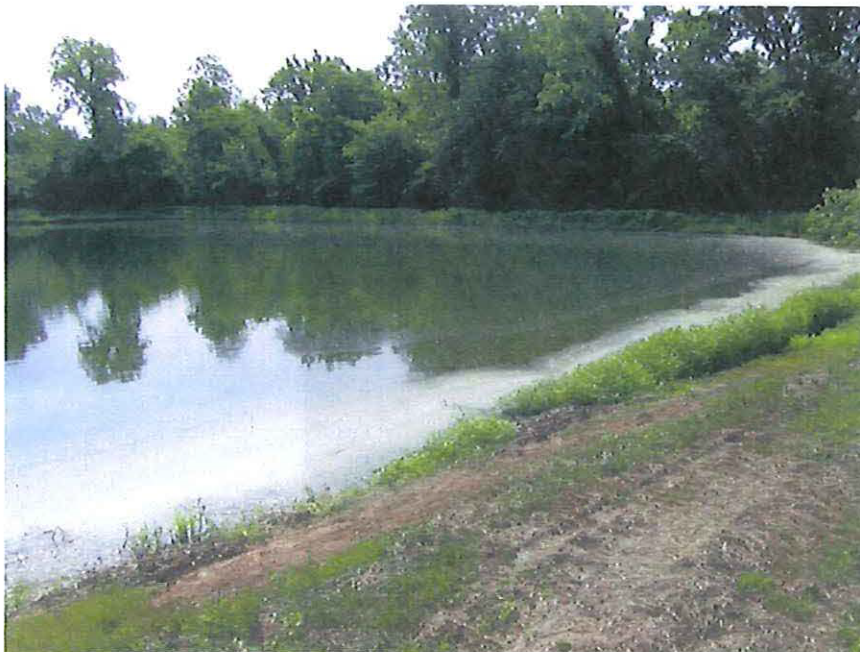
During the walk around the West North Lagoon, FOIA Exemption (b) (6) stated that the East North Lagoon was not in use as a manure storage structure and he planned to leave it unused. He irrigates from this lagoon when it gets full.

IMG_0328: East North Lagoon is not connected to West North Lagoon. FOIA Exemption (b) (6) does not intend to use the East North Lagoon and irrigates from it when it is full. Note the trees growing on the side of the berm.

The berms of both the East and West North Lagoons contained trees and woody growth. EPA stressed to **FOIA Exemption (b) (6)** that the trees and woody growth needed to be removed to preserve the integrity of the berms.

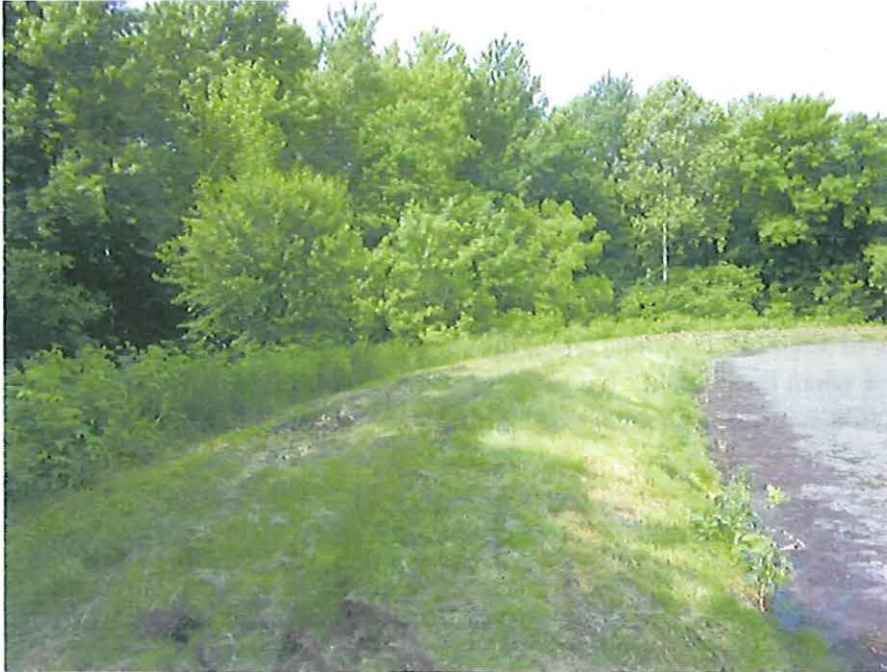
IMG_0331: Woody growth on berm of West North Lagoon. FOIA Exemption (b) (6) was informed that the trees and woody growth needs to be removed.

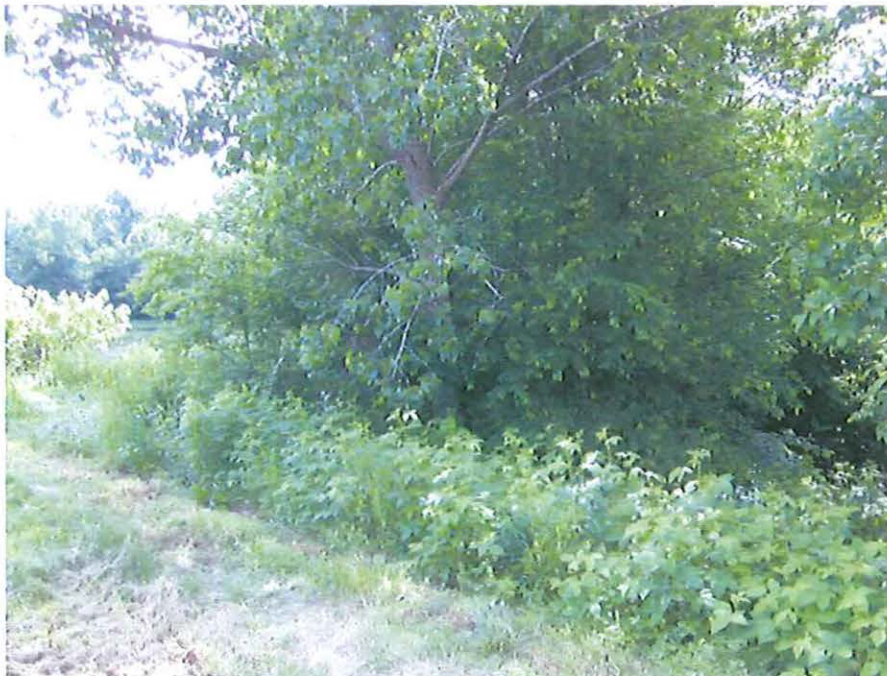
IMG_0333: Woody growth on berm of West North Lagoon.
